Infrared Inspection Report Roof System

Test Project
10101 Anywhere Lane
Here, CA 91606

Report Date: 10/18/2017

Job Number: 17-1161.01

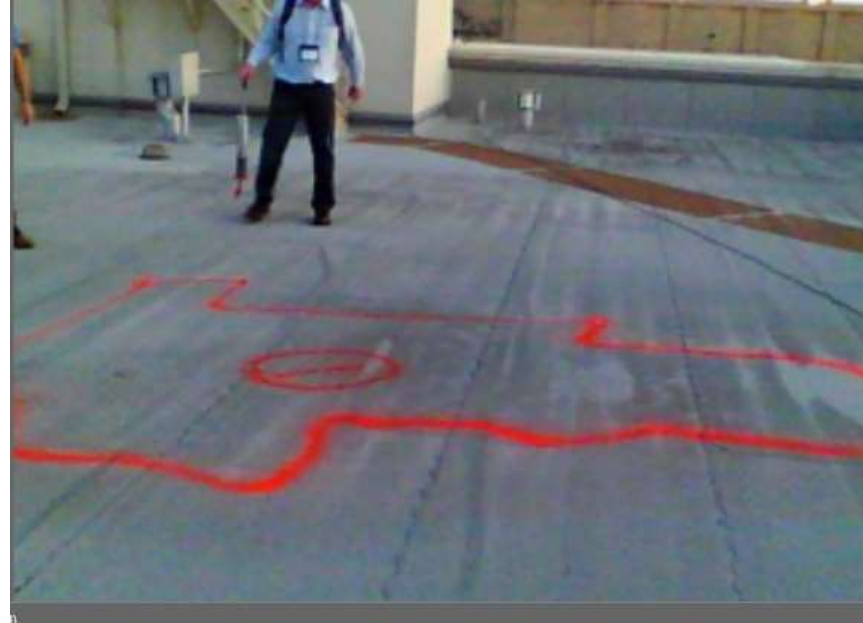
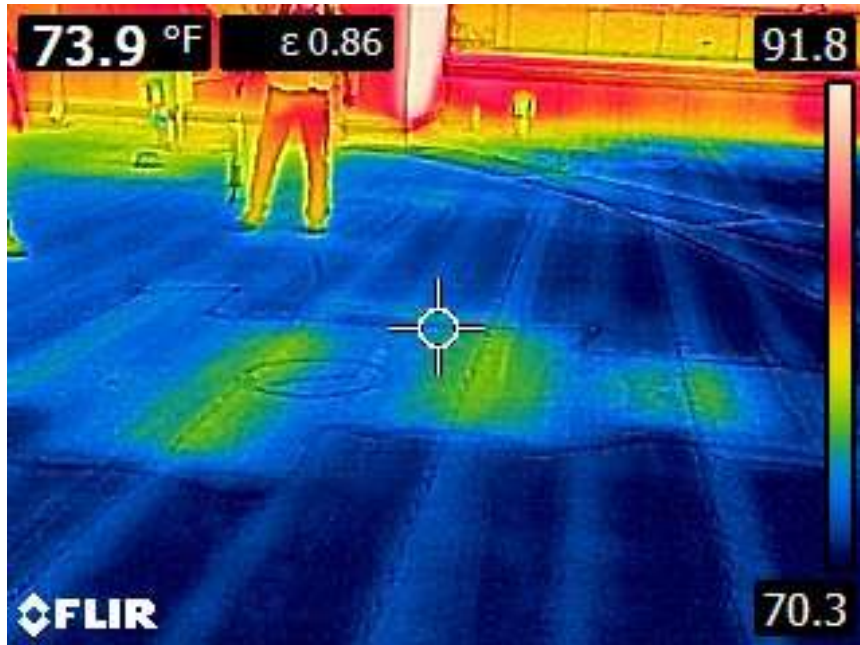
No. 1 **Job No.** 17-1161.01 **Date** 10/2/17 **Time** 8:45 pm

Ambient Temp 78 °F **Damage Type** Moisture

Blisters present: Yes Other: N/A

Comments Moisture Trapped in Roof

Subj.
Priority 1

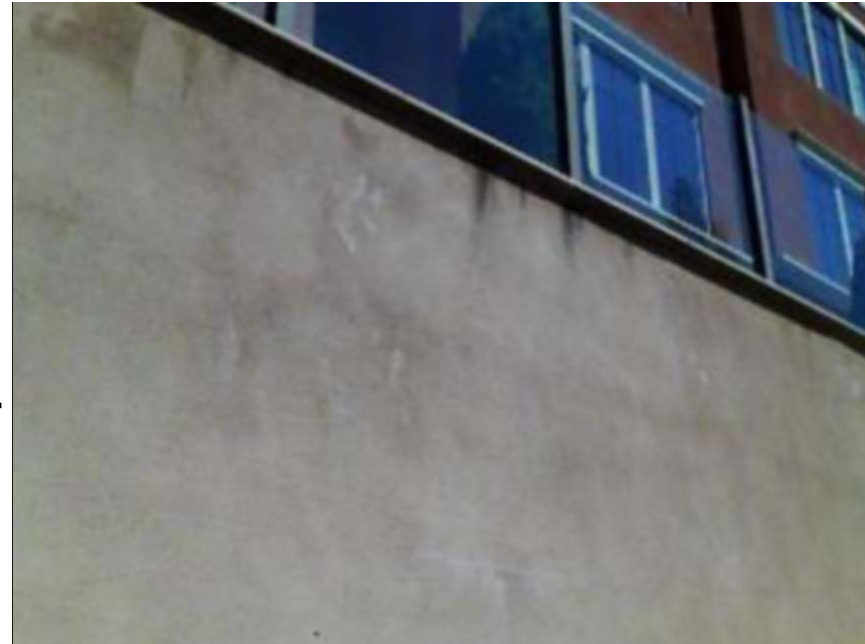
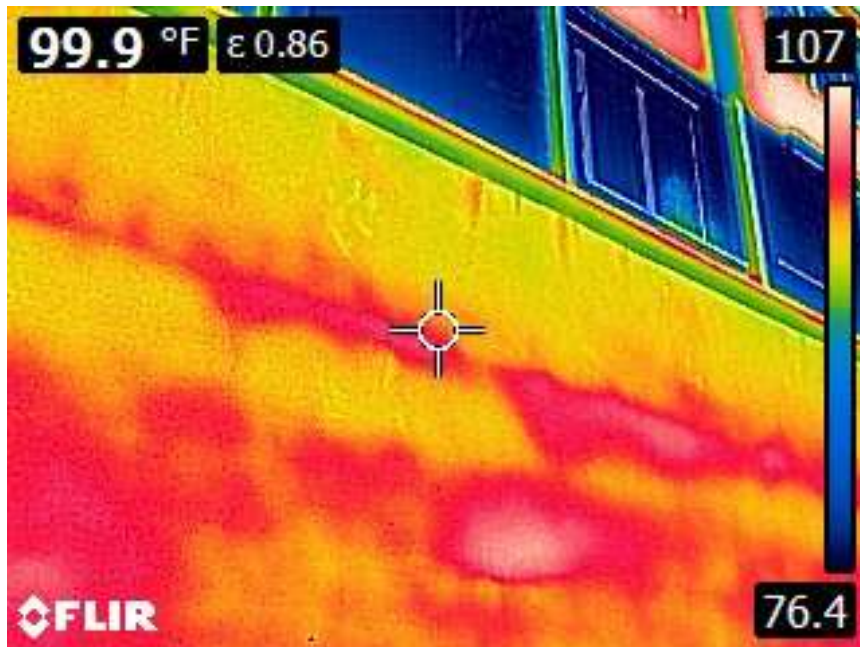
No. 2 **Job No.** 17-1161.01 **Date** 10/3/17 **Time** 9:00 pm

Ambient Temp 85 °F **Damage Type** Moisture

Blisters present: Yes Other: N/A

Comments Water damage thru stucco wall

Subj.
Priority 2

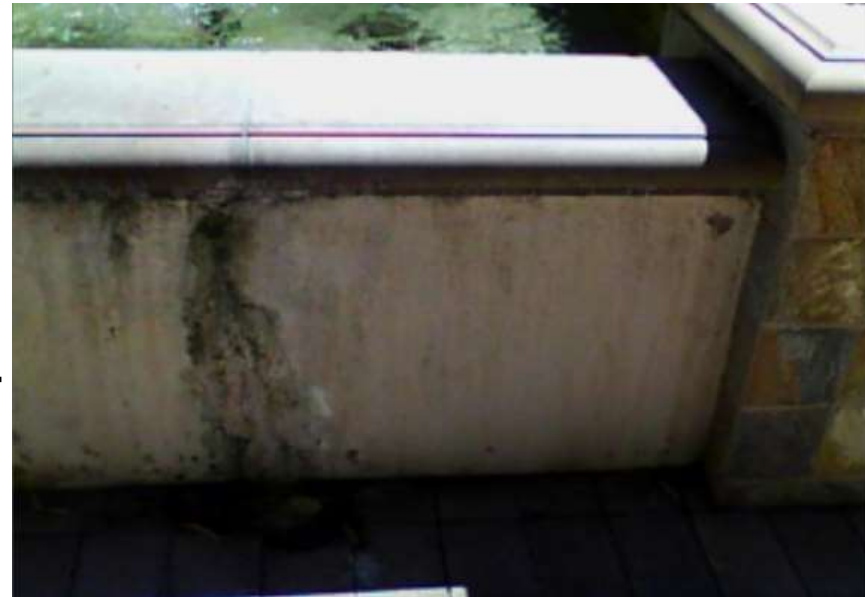
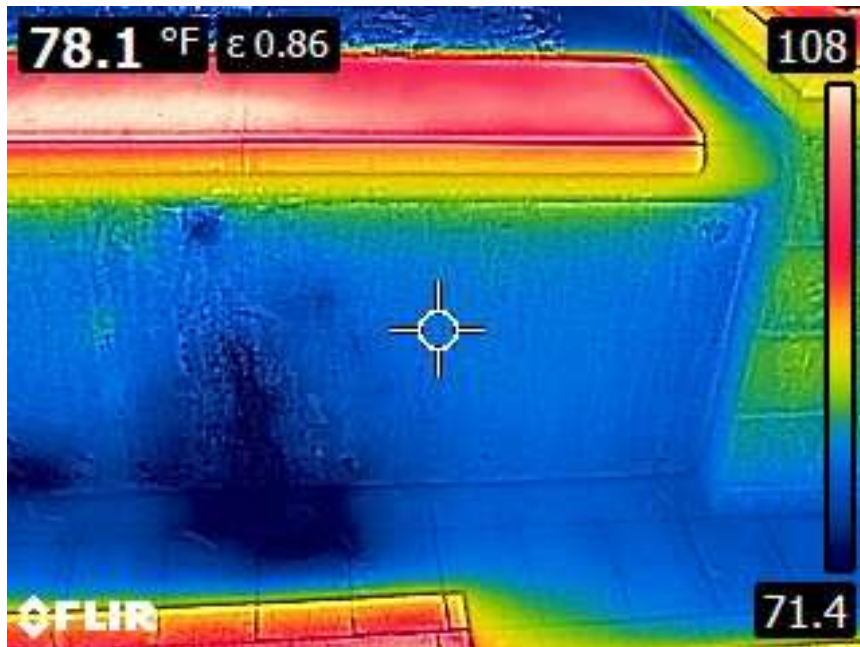
No. 3 **Job No.** 17-1161.01 **Date** 10/3/17 **Time** 9:15 pm

Ambient Temp 85 °F **Damage Type** Moisture

Comments Water damage to fountain wall
